## Site Features Inventory Report

**Barite Hill Mine  
McCormick, South Carolina**

Prepared By: Michael Gobla, P.E.

July 2007

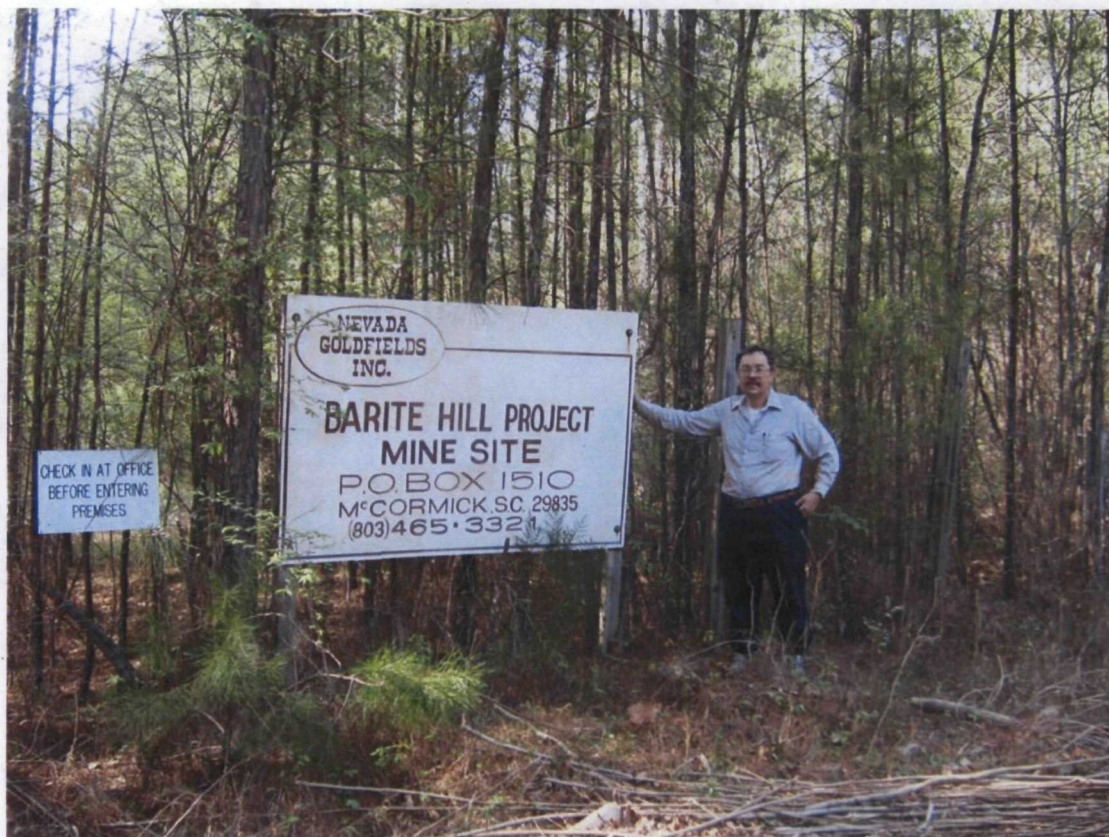
**Figure 2.** This sign adjacent to the site entrance gate identifies the mine and is visible from Road 30. The small sign at the left stating "check in at office before entering premises," is no longer valid and should be removed.

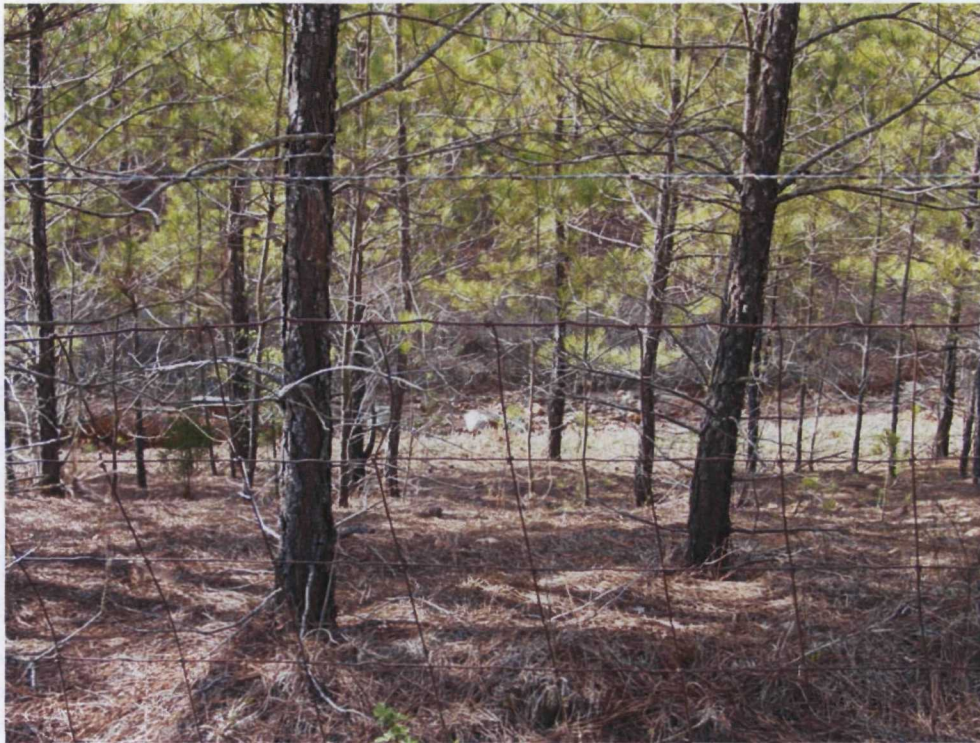
**Figure 5. Close up view of fencing around the Process Plant Contingency Pond showing a smooth-wire grid and an upper single strand of barbed wire.**

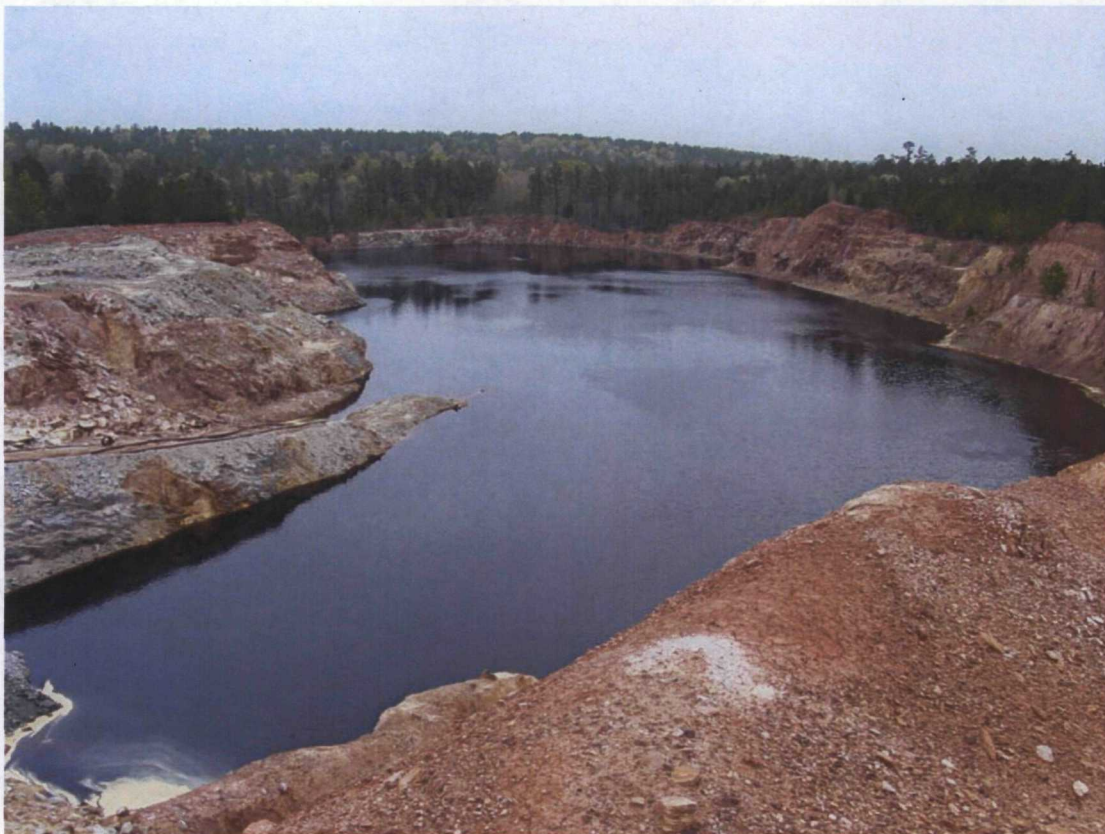
**Figure 9. The most significant hazard remaining at the site is the Barite Hill Pit.**

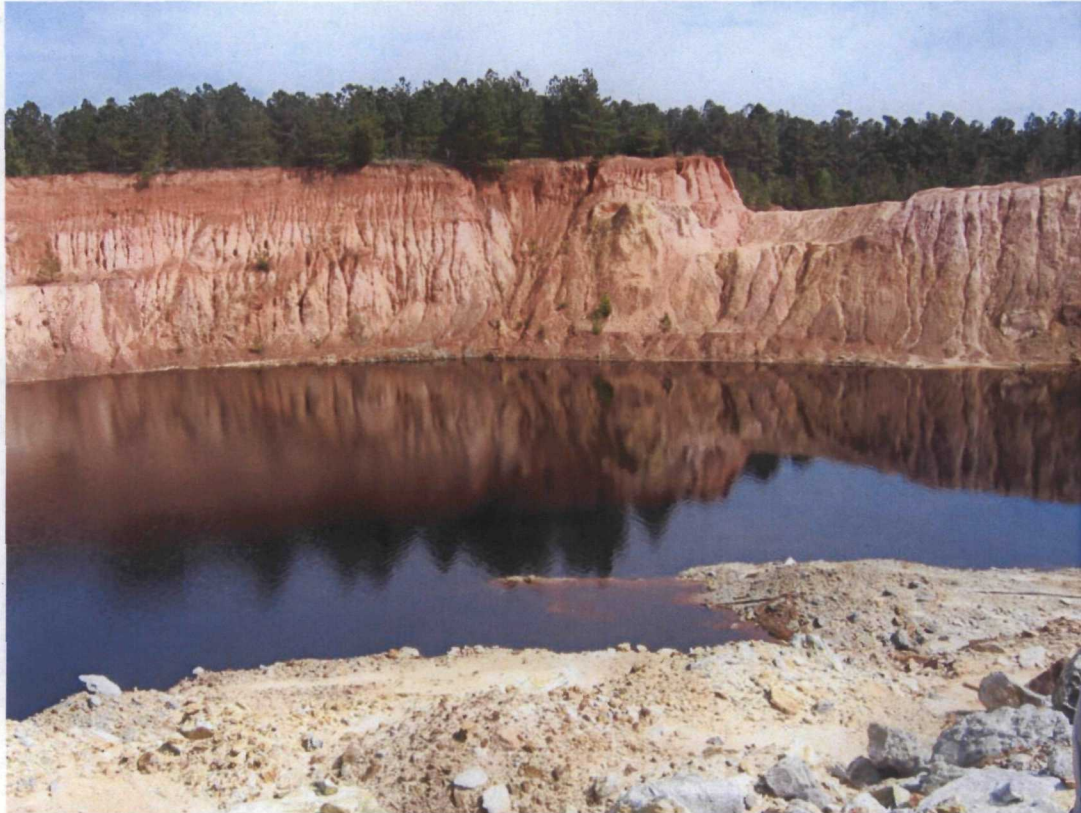
**Figure 10. Photograph looking towards east side of the pit. The east highwall area shows signs of volunteer vegetation and it likely has a relatively low permeability. In the upper right part of the photograph, the excavation from the clay borrow area can be seen which removed the top layer of red-colored clay soil.**

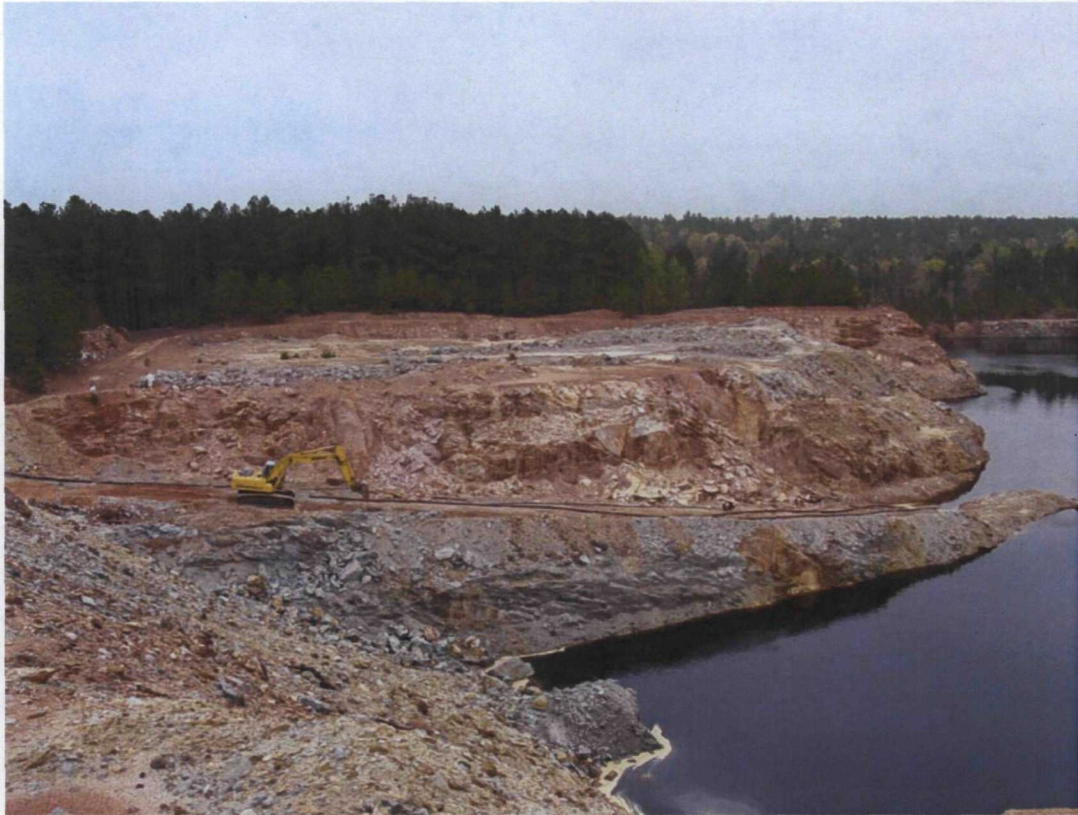
**Figure 13. View of grey-colored rocks rich in pyrite on the west side of the pit.**

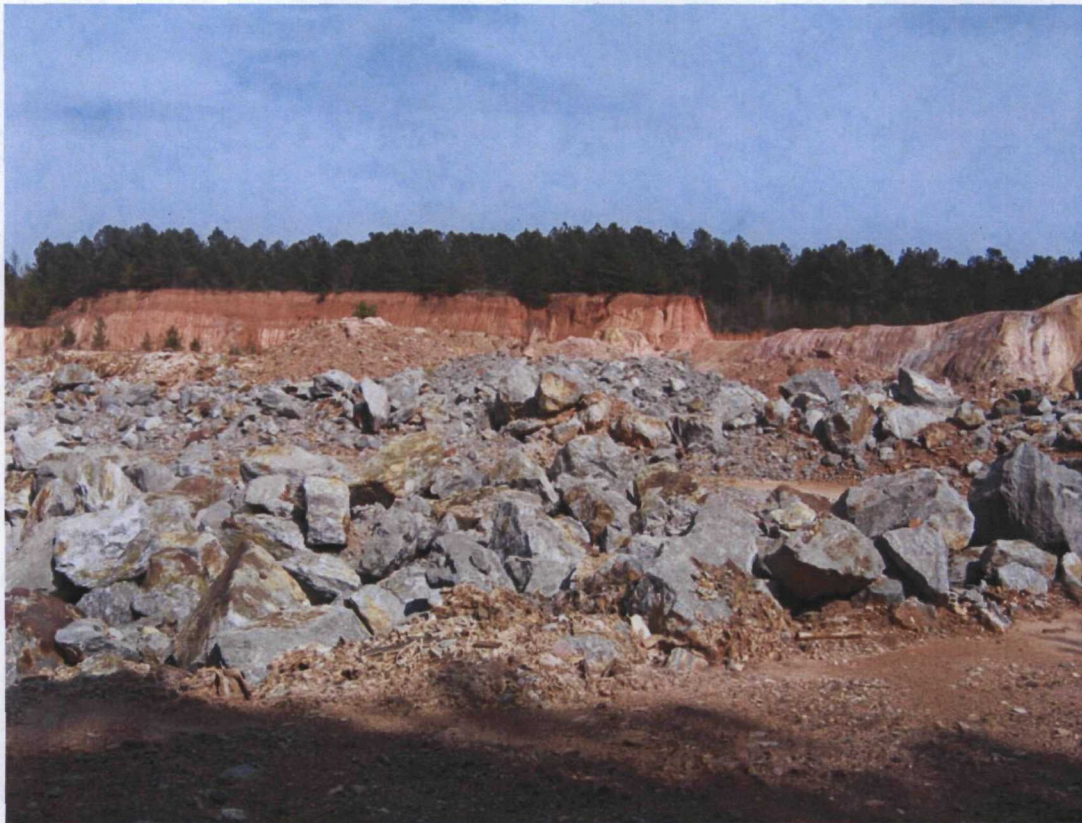
**Figure 15. Close-up view of some of the pyrite-containing waste rock piles dumped onto the upper benches on the west side of the Barite Hill Pit.**

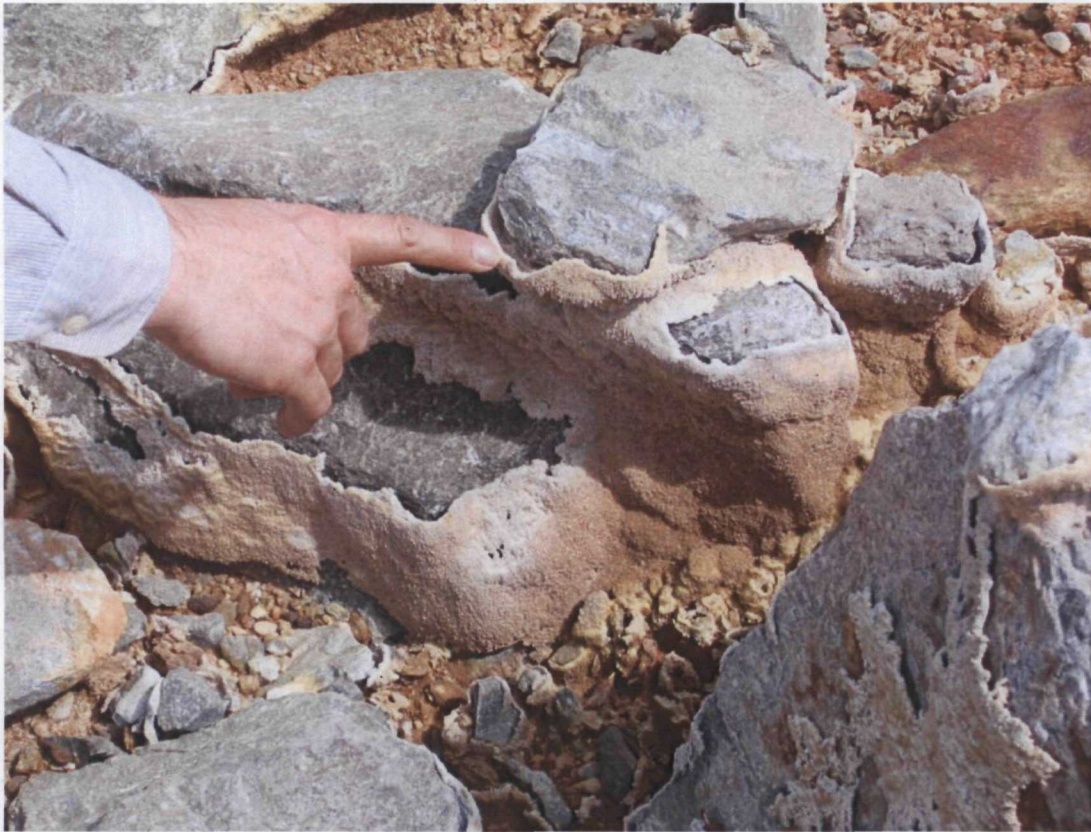
**Figure 16. Photograph of damaged “gunite” coating on pyrite-rich waste rock left exposed in the upper benches of the Barite Hill Pit. The coating is a failed attempt to mitigate the acid drainage originating from this waste rock.**

The gunite, a calcium-carbonate-rich spray-applied coating on the waste rock piles, was not successful in preventing acid generation. The gunite coating could not penetrate into the fine-grained portion of the pyrite-rich waste where most of the acid is generated (Acid formation is proportional to surface area of pyrite exposed to moisture and oxygen). Also, the gunite coating has very little tensile strength and is porous. It is easily fractured and loosened by temperature extremes and freeze-thaw action. In time the gunite was fractured, loosened, and removed by the weather.

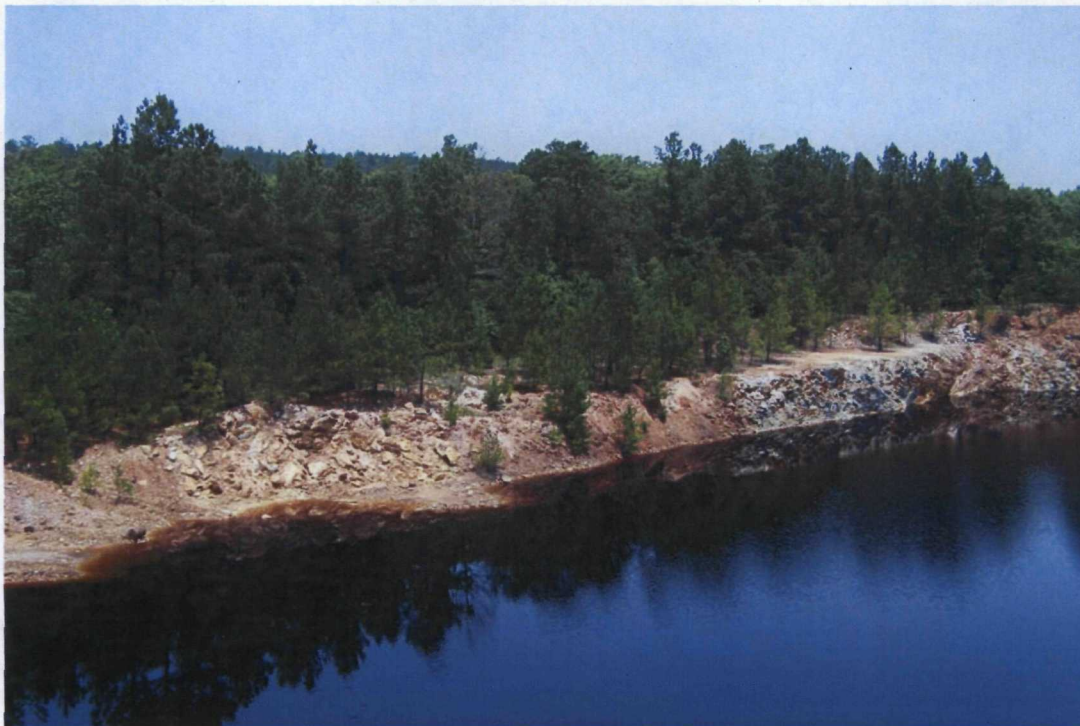
**Figure 18. View of the north pit wall where outflow from the pit will eventually occur.**

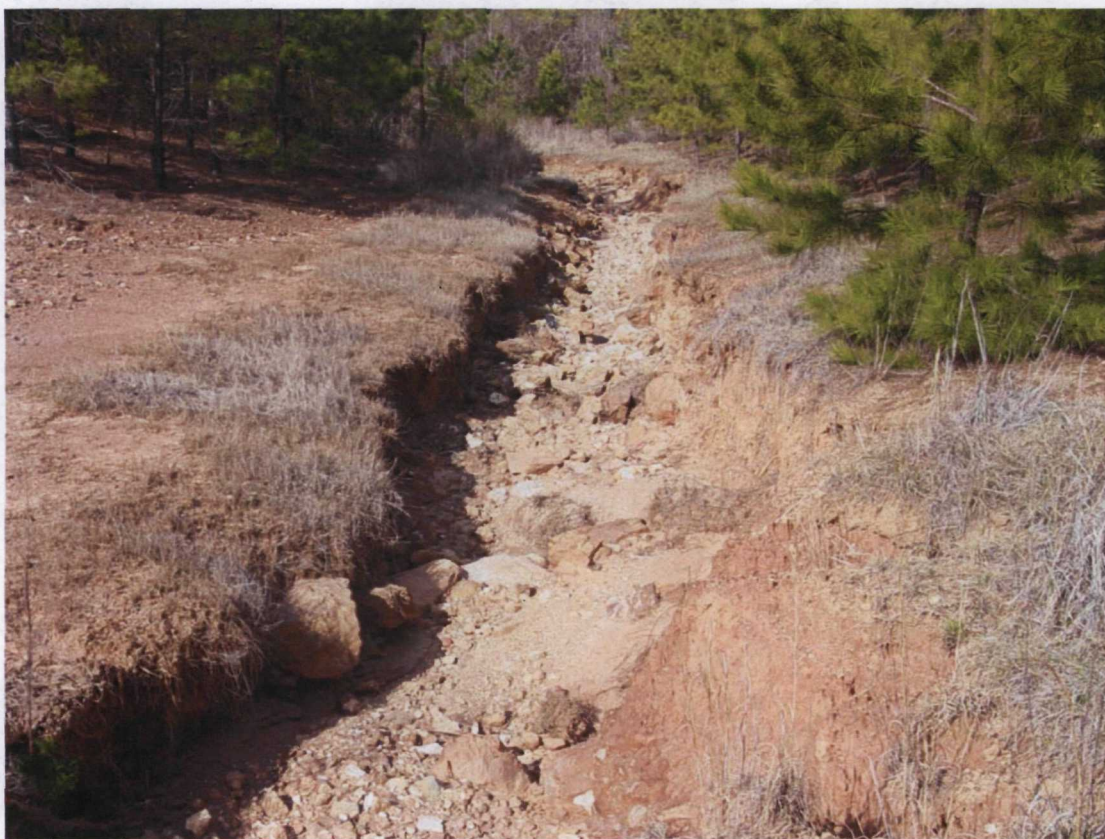
**Figure 21. View to the west of the eroded diversion ditch on the north side of Waste Rock Disposal Area A. Significant amounts of pyrite rich waste rock are present in this eroded channel which is likely a source of acid drainage.**

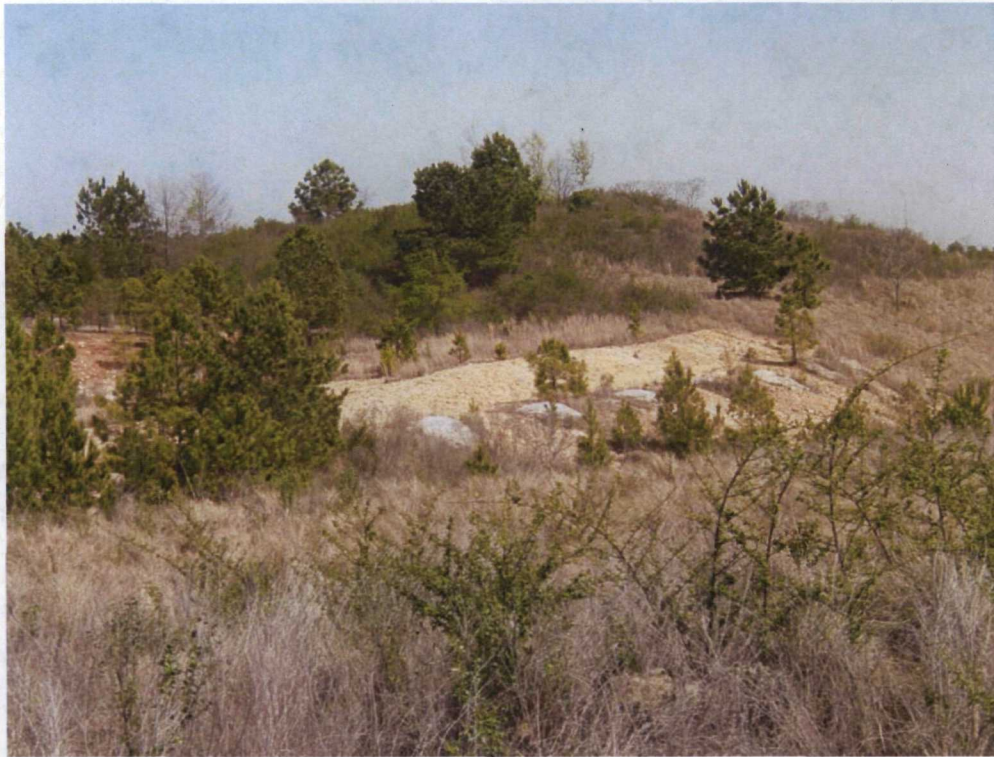
**Figure 23. View of incomplete reclamation on the west side of the Industrial Solid Waste Landfill. Note that organic matter (brown ring around white piles) and slaked lime (white piles) have been dumped but were not spread and incorporated into the mine waste. One deep erosion gully (see Fig. 24) cuts down through this unreclaimed slope to the right and a shallow gully (see Fig. 24) is eroding the unreclaimed area on the left side of the photograph.**

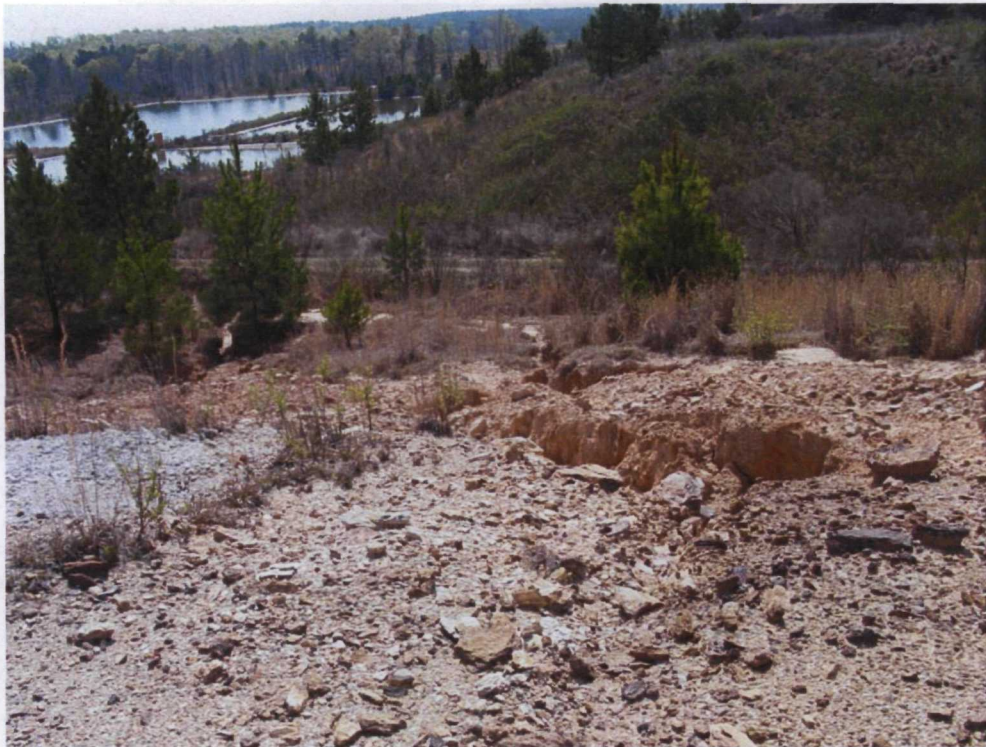
**Figure 24. Deeply incised erosion gully in un-reclaimed slope of the Industrial Solid Waste Landfill.**

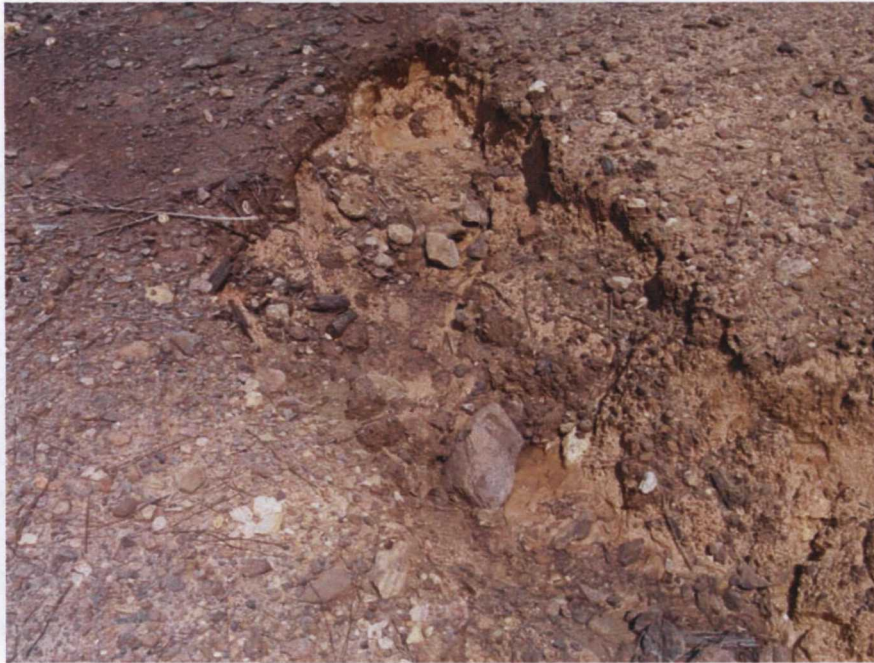
**Figure 26. Seepage discharging from near the bottom of the slope of the west side of the Industrial Solid Waste Landfill.**

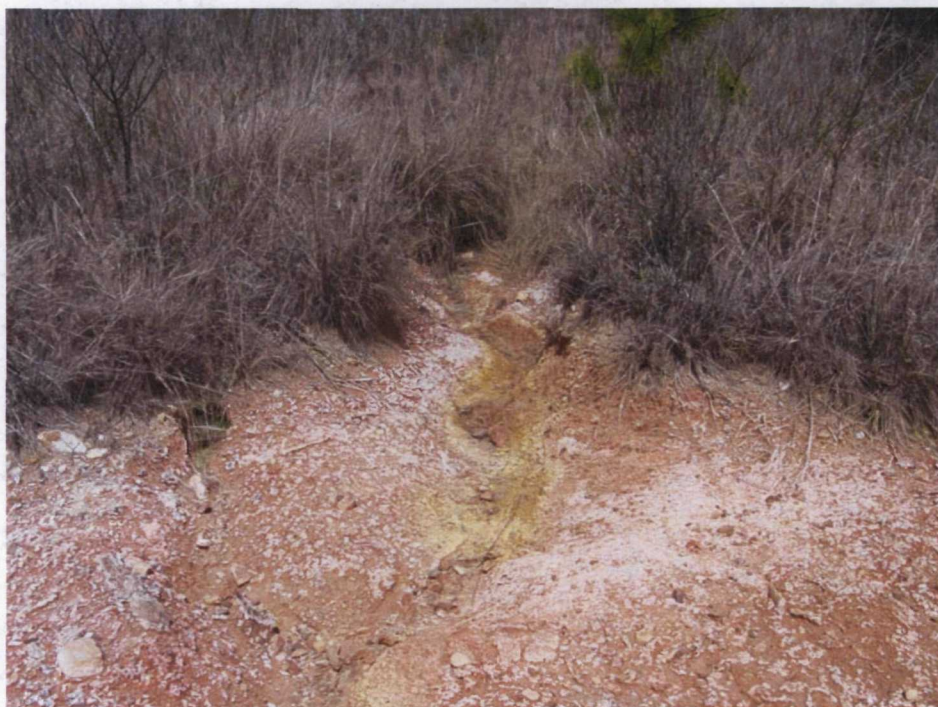
**Figure 29. Photograph of the largest of the acid seeps emerging from the southeast side of the Permanent Heap Leach Pad. Yellow staining is the result of precipitation of iron hydroxides. The white coatings on the adjacent bare soil are thought to be the iron sulfate mineral melanterite.**

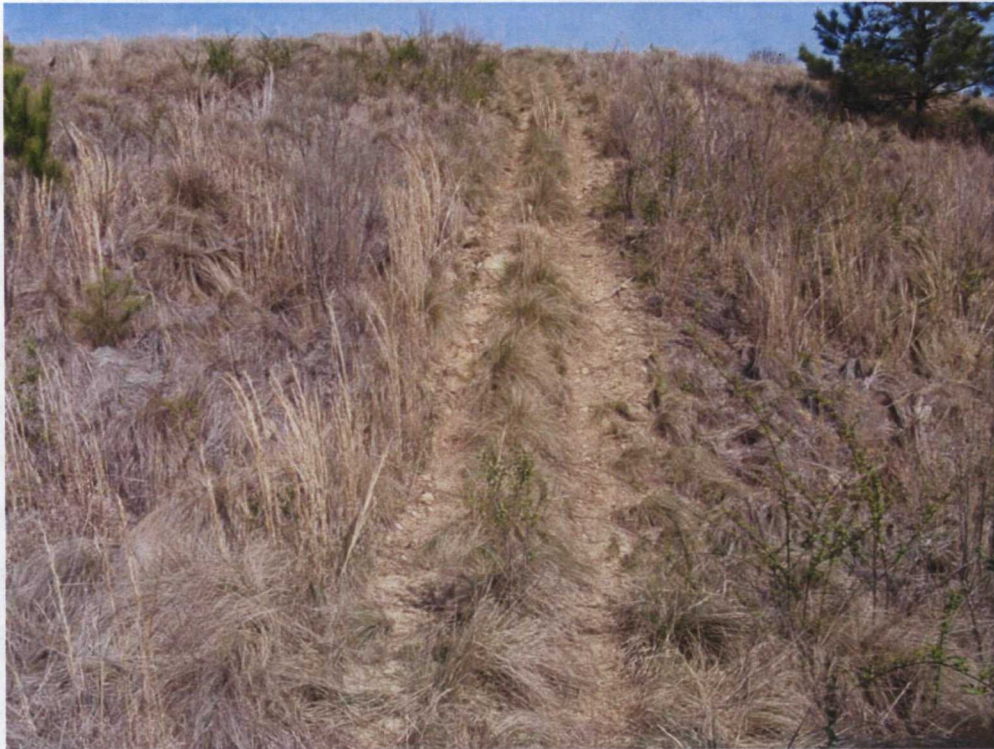
**Figure 30. Rutting on the Permanent Heap caused by ATV use.**

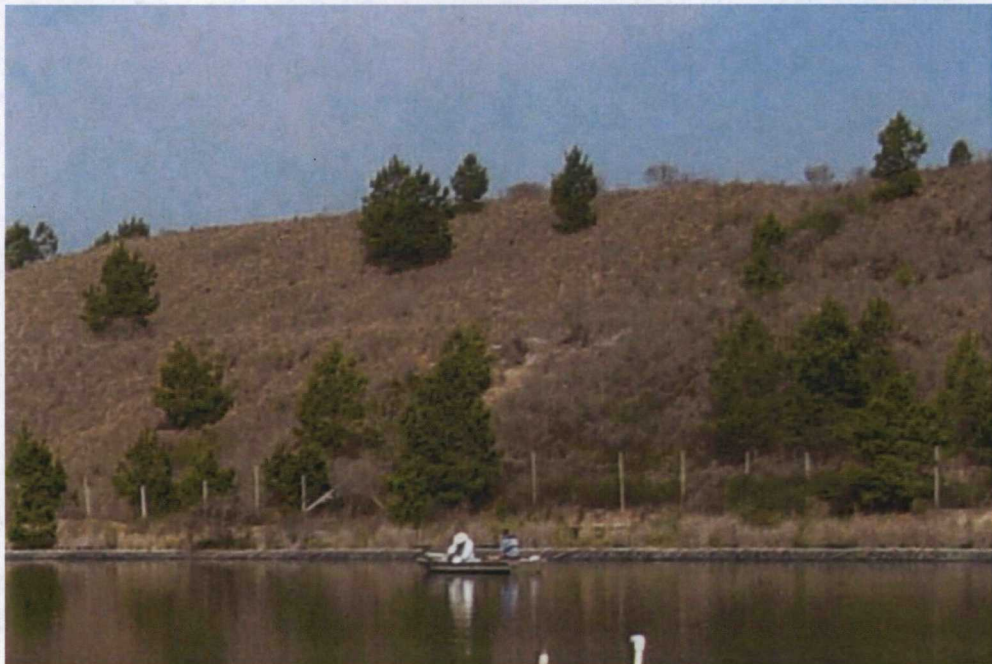
**Figure 31. Erosion of drainage down chute can be seen as the disturbed area on the hill side above the men in the boat.**

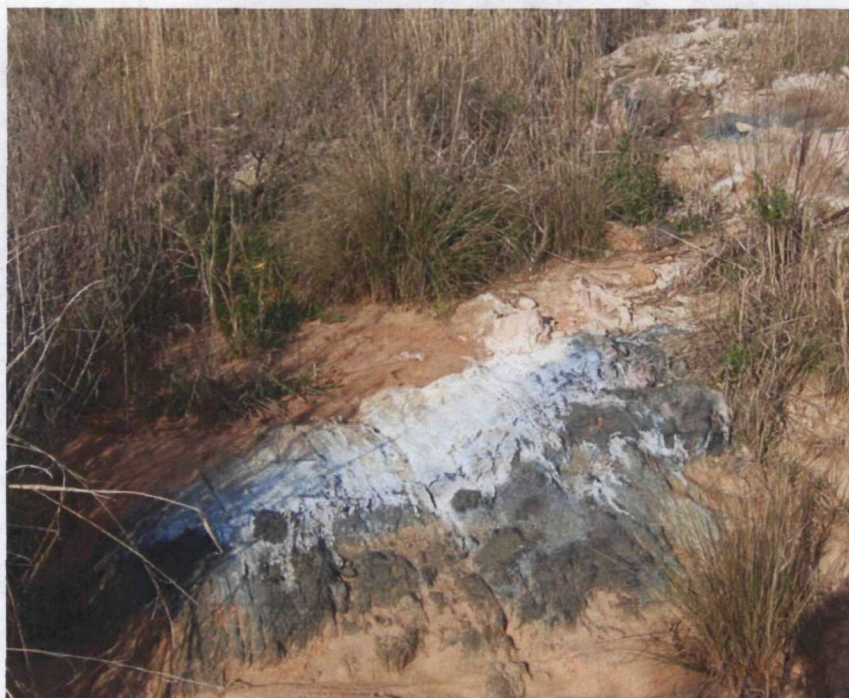
Figure 49. Prussian blue stains on bedrock in the crusher area.

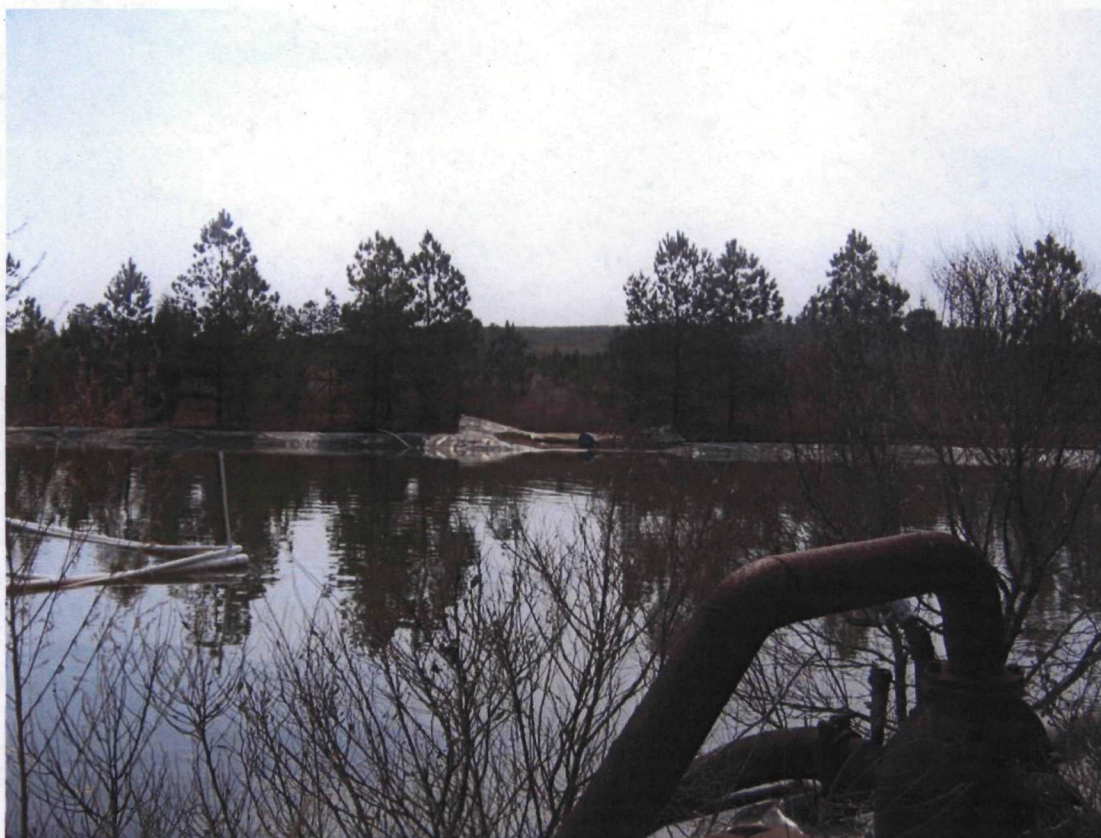
**Figure 51. Photograph of the Process Plant Pregnant Pond. The view across the pond shows the seepage inflow area from the Reusable Heap-Leach Pad. An electric pump can be seen at lower right.**

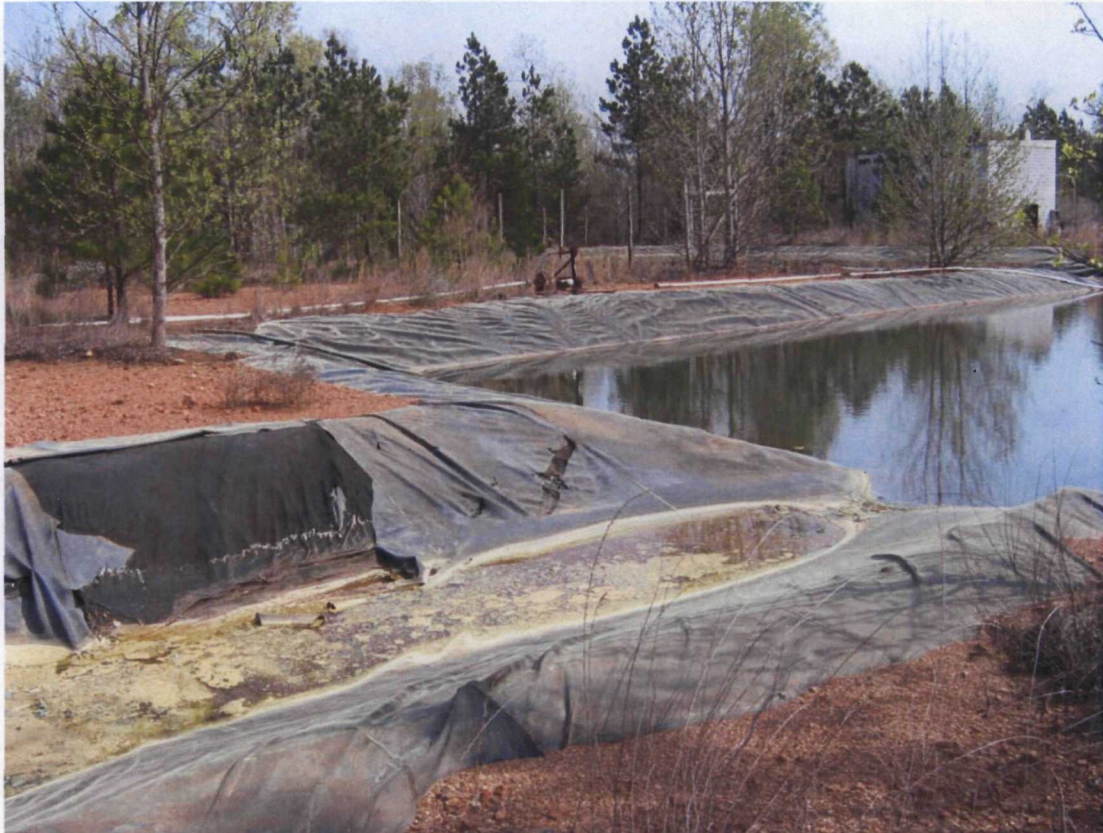
**Figure 53. Discharge channel and the west portion of the Process Plant Rinse Pond. This pond, like those upstream of it, is full, all additional precipitation results in discharge to the unlined Process Plant Contingency Pond.**

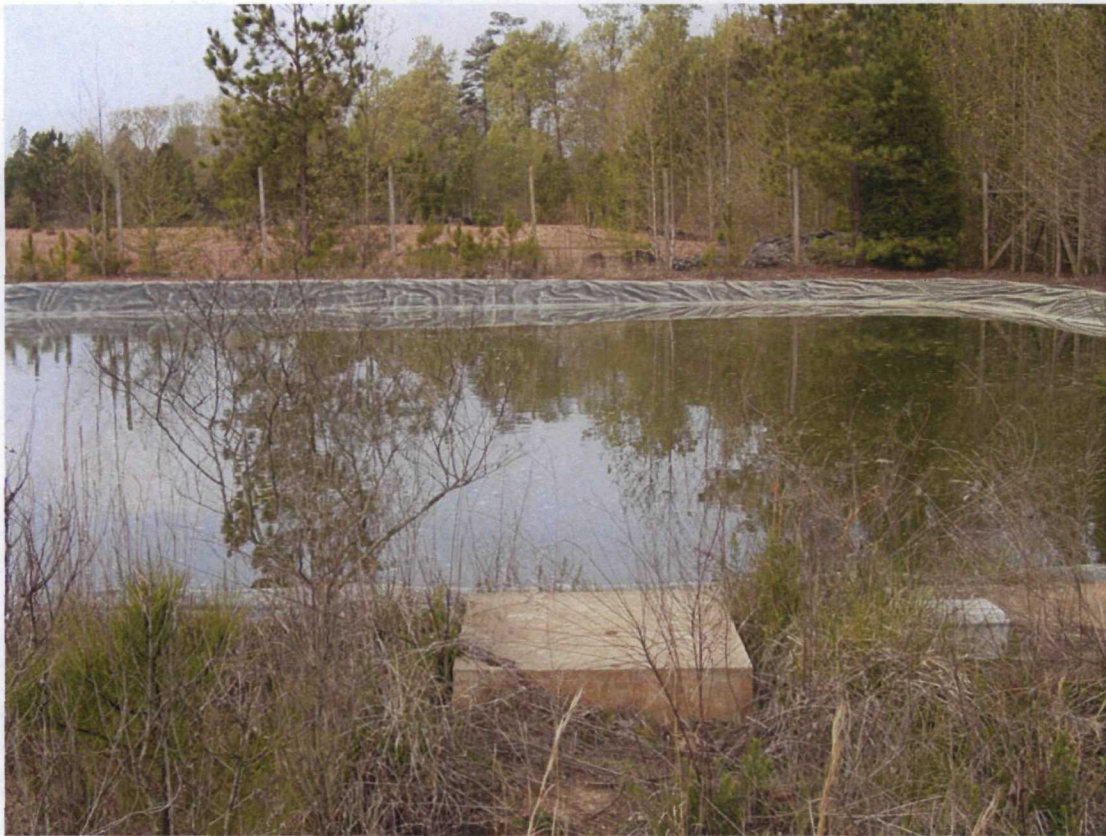
**Figure 54. Photograph of the Process Plant Carbon Pond. The electric pump has been removed from its concrete base.**

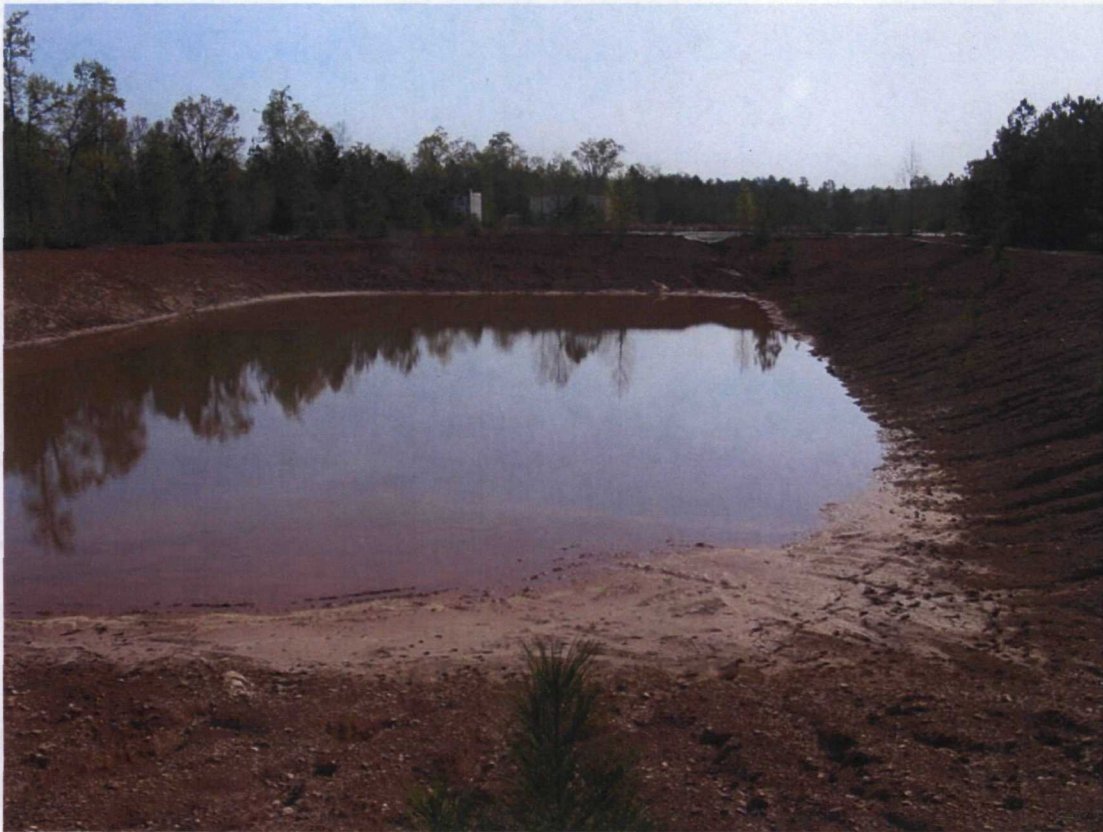
**Figure 55. View of the Plant Contingency Pond (view looking towards the west). Note that the liner has been cut and removed. The slope in the right side of the photograph is weathered bedrock. The slope in the left side of the photograph is a fill embankment through which water is seeping.**

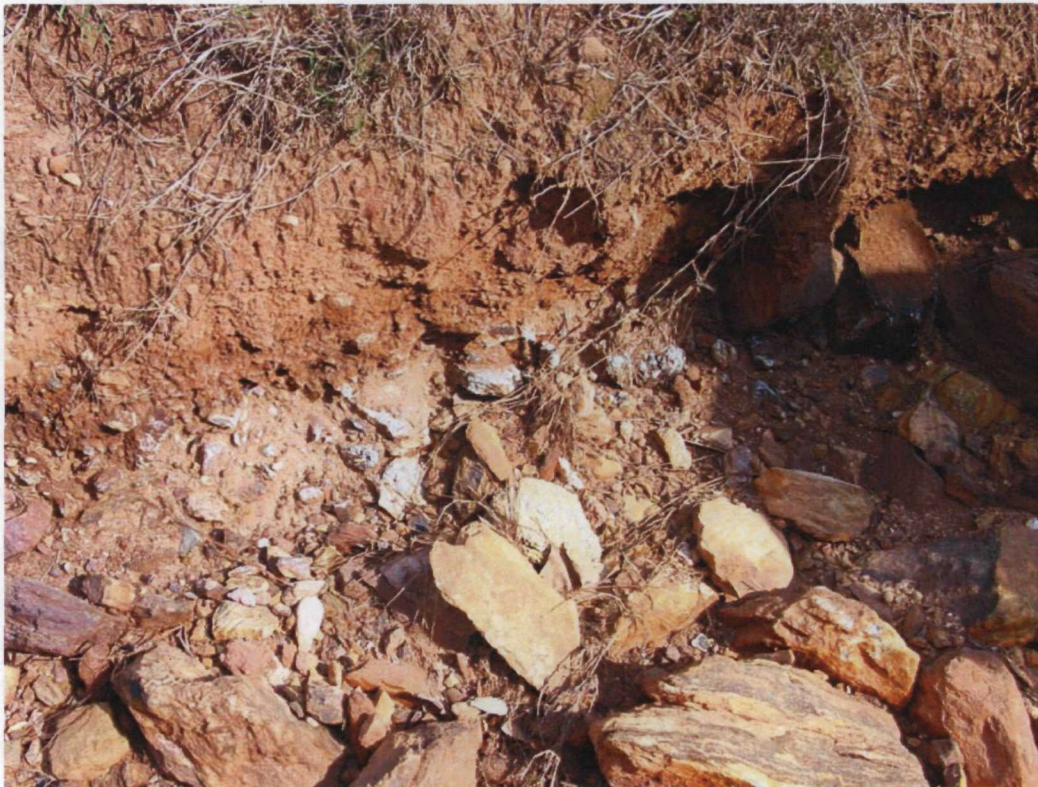
**Figure 57. Damp soil at the seepage line along the toe of the fill embankment supporting the Process Plant Contingency Pond. Note the prussian blue coating the rocks below the damp soil.**

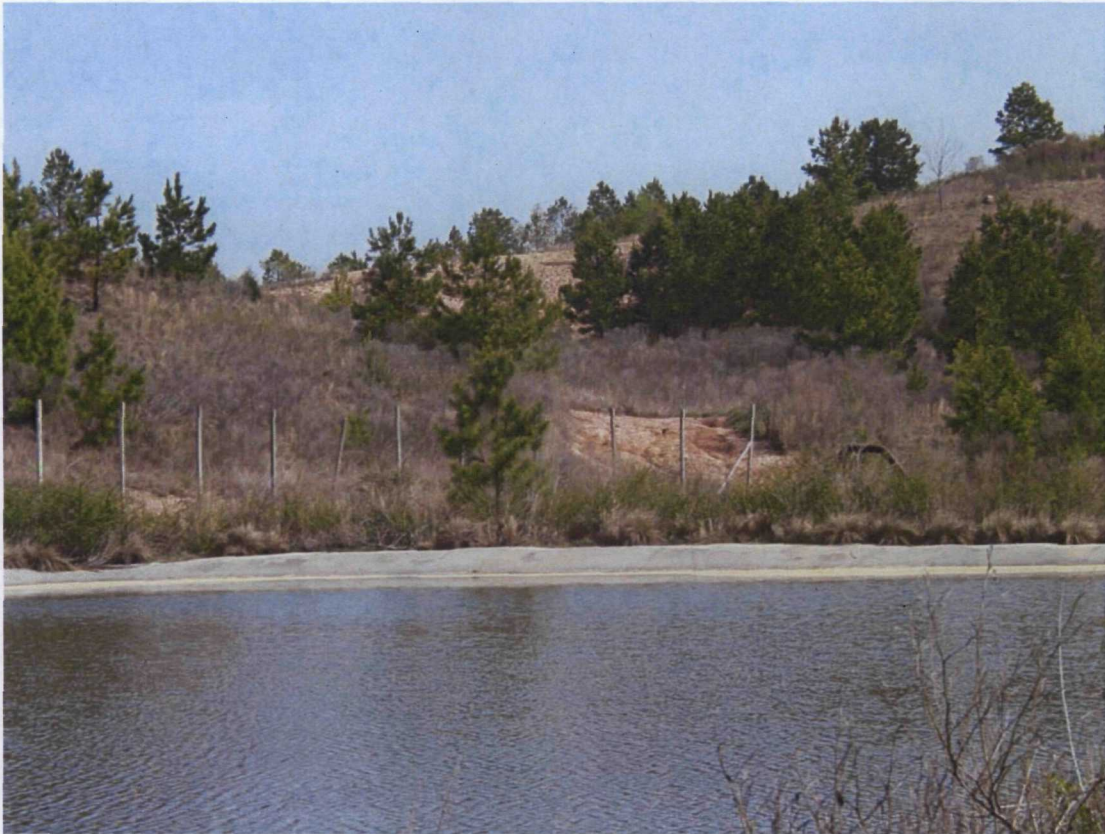
**Figure 59. View of the Permanent Heap Rinse Pond. The disturbed area just above the pond is the location of a major acid seep from the Permanent Heap Leach Pad which is lowering the pH of this pond.**

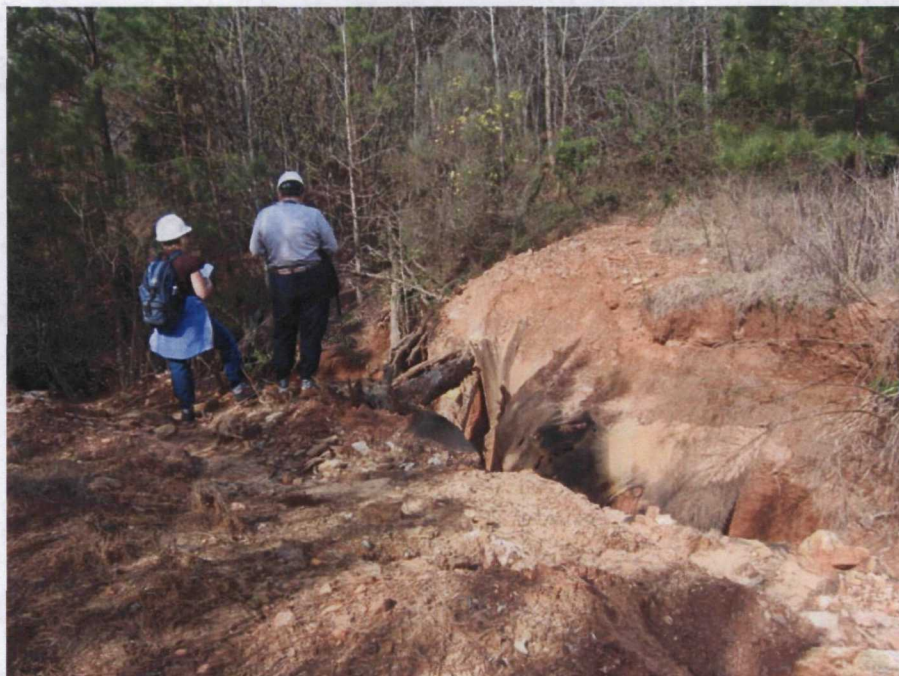
**Figure 64. Failed sediment control structure on eroded diversion ditch near the Process Plant Contingency Pond.**

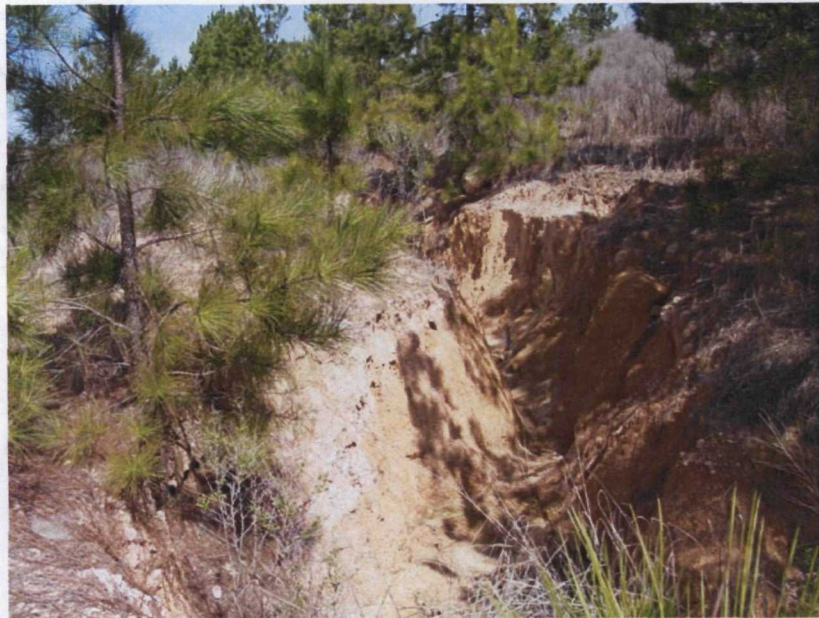
**Figure 65. Erosion of diversion ditch adjacent to the Industrial Solid Waste Landfill.**

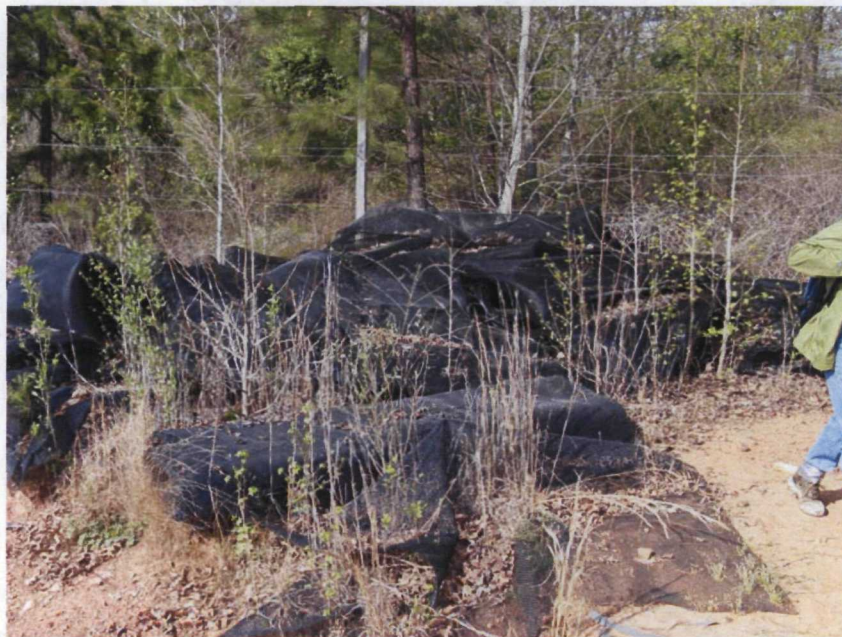
**Figure 68. Discarded geonet drain material lies next to the Contingency Pond.**
